Analysis Report - Evidence of Mold & Bacteria in Vehicle Ventilation Systems; Removal/Reduction using MiST™; Comparison Study and; Odor Study

Part 1: Evidence of Mold & Bacteria and Result of MiST™ Service

Part 2: Comparison of MiST™ to other Existing Products Available

Part 3: Effectiveness of the MiST™ Active Odor Control

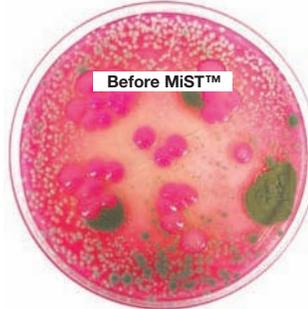
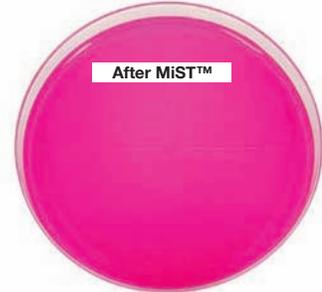
2004 Porsche equipped with cabin air filter (29,000 km/18,000 miles)

Part 1 Observations: Petri dishes showing mold before and after MiST™ service

Part 1 Conclusions: The observations confirm evidence of mold in all of the test vehicles ventilation systems. Samples taken 2 days after running the MiST™ service demonstrate that none or very little mold is present in the ventilation system.

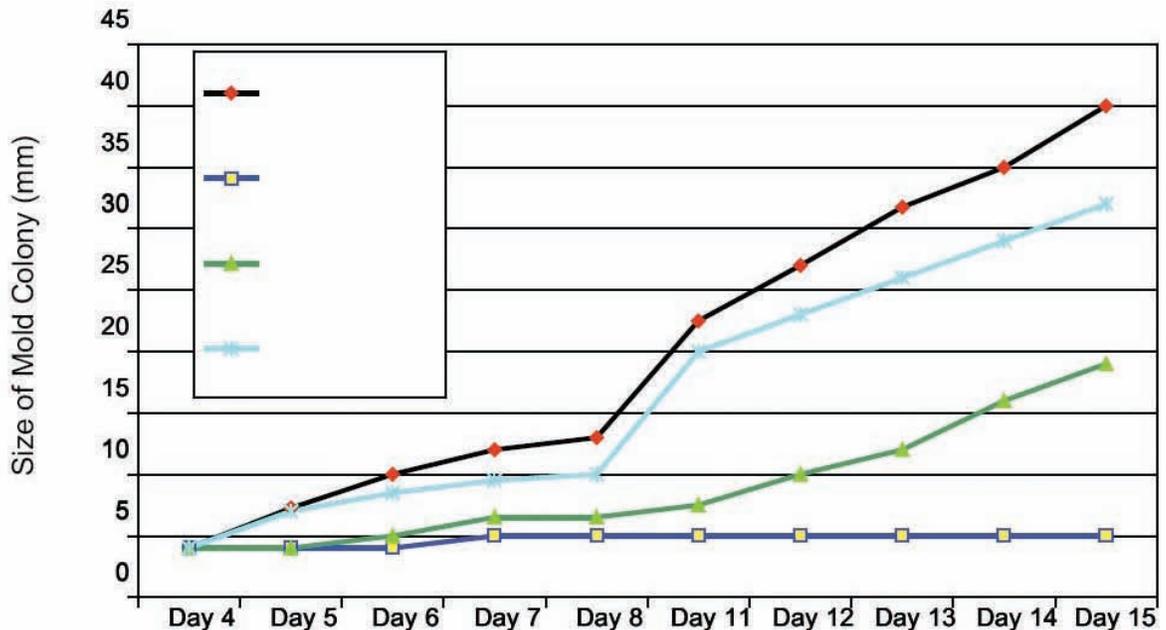
Rate of Mold Growth Direct Contact

1. Mold Plates were prepared by Gelda Scientific containing mold spores. The mold spores were allowed to grow for 4 days before they were treated.
2. 10 ml of the Febreze®, Wynn's® Airco Clean new biodegradable formula and MiST™ Cleaning Solution were poured directly onto a mold plate and allowed to soak the mold spores for 10 minutes and then poured off. One mold plate was not treated and used as a control.
3. After treatment, the mold plates were stored at room temperature. Digital photographs of the mold were taken at 5, 8 and 15 day intervals. The sizes of the mold colonies were charted (see graph below).

Part 2 Conclusions: The MiST™ cleaning solution demonstrated no mold growth over the 15 day reporting period. The Febreze® and Wynn's® solution demonstrate only a slight reduction in mold growth as compared to the control.

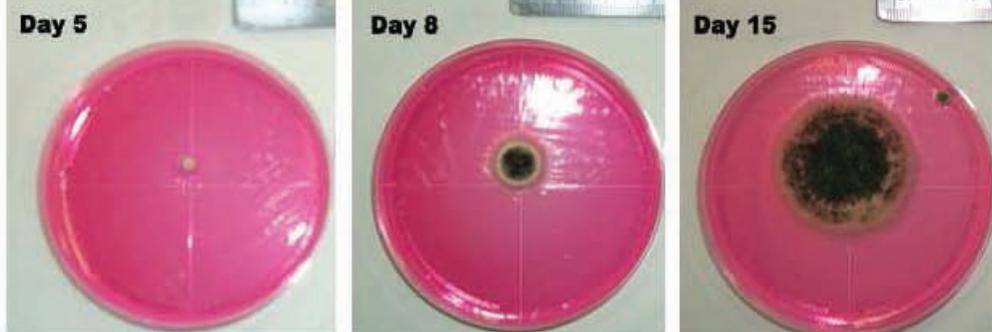
Control - Untreated Mold

Part 2 Observations: Petri dishes showing mold growth at 5, 8 & 15 days
